Manhole Inspection Summary

Manhole # S15EE2023MH

Insp Date: **7/13/06 9:40 AM**

Location Address: **1919 FAIRBANK RD**

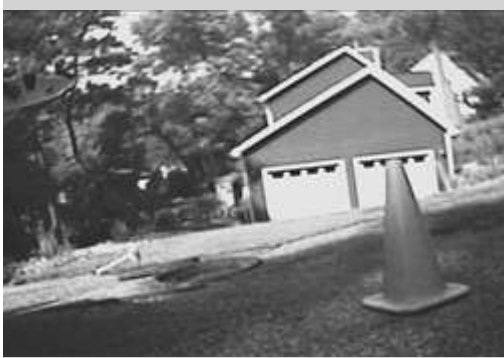
Location View

Comments **Cracks in pavement around manhole. Possible source of infiltration.**

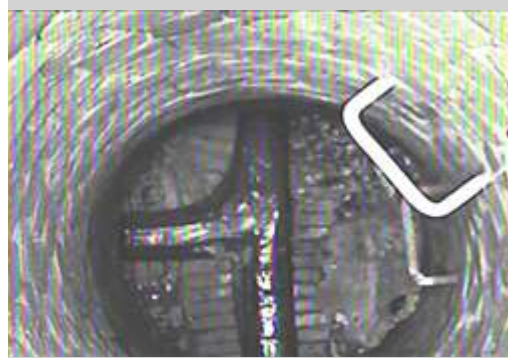
Top View

Bench debris. Corroded steps.

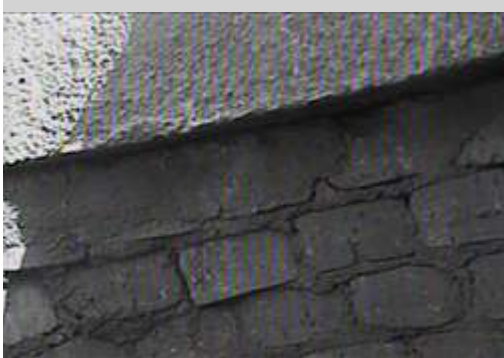
Defect

Frame leaks. Corbel deterioration and infiltration.

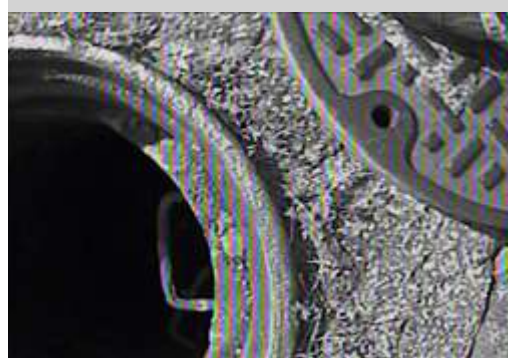
Defect

Frame offset. Corbel infiltration.

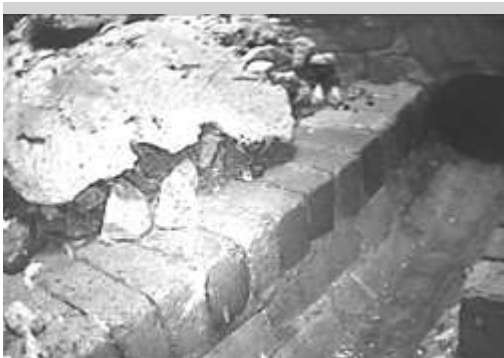
Defect

Bench debris.

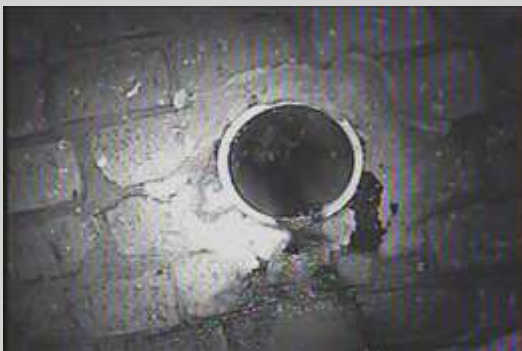
4 in. Circular Gravity Sewer Pipe In @ 2 O'Clock

Infiltration: **Evidence** Pipe Seal Cond: **Unknown**

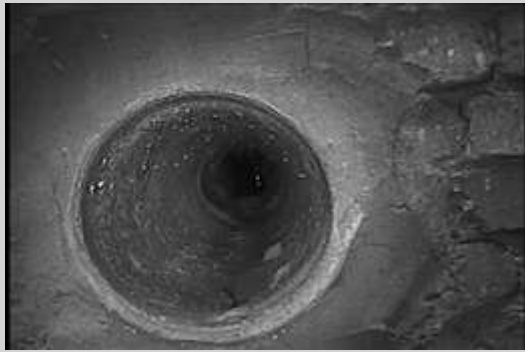
Pipe In @ 6 O'Clock

Infiltration: **Evidence**

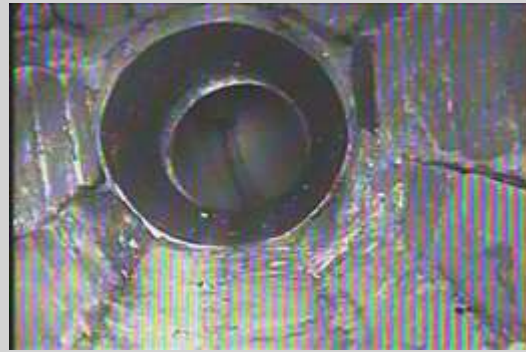
Drop In @ 6 O'Clock

Channel deterioration.

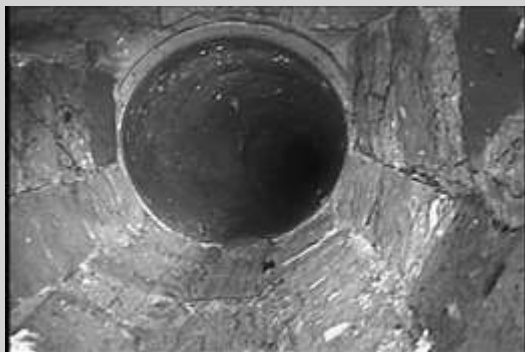
Pipe In @ 9 O'Clock

Pipe Seal Cond: **Cracked**
